## Test Report

RPT No. 060409.014

**Sample:** R116 Rose Quartz  
**Country of Origin:** Brazil  
**Sample Quantity:** Two (2) stones  
**Sample Received:** April 3, 2009  
**Testing Period:** April 4 – 5, 2009

**Test Requested:** Method CPSC-CH-E1001-08 for US 16 CFR 1303, lead accessible substrate, For US Public Law 110-31

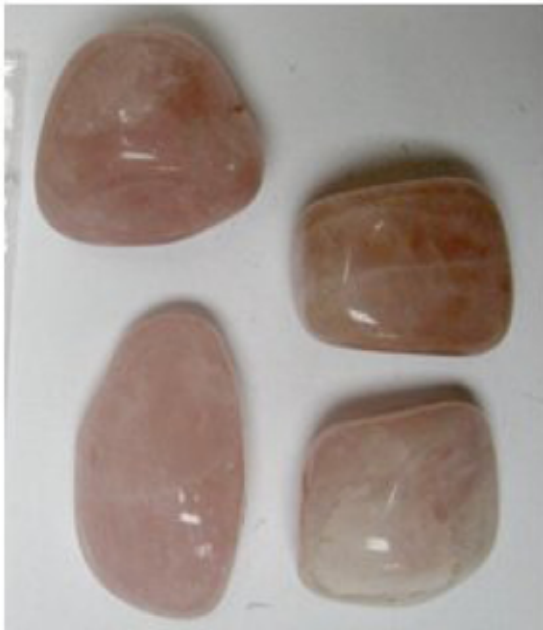
**R116 Rose Quartz**

### Sample Photo:
