### Test Report

RPT No. 060409.015

**Sample:** R115 Quartz  
**Country of Origin:** Brazil  
**Sample Quantity:** Two (2) stones  
**Sample Received:** April 3, 2009  
**Testing Period:** April 4 – 5, 2009

**Test Requested:** Method CPSC-CH-E1001-08 for US 16 CFR 1303, lead accessible substrate, For US Public Law 110-31

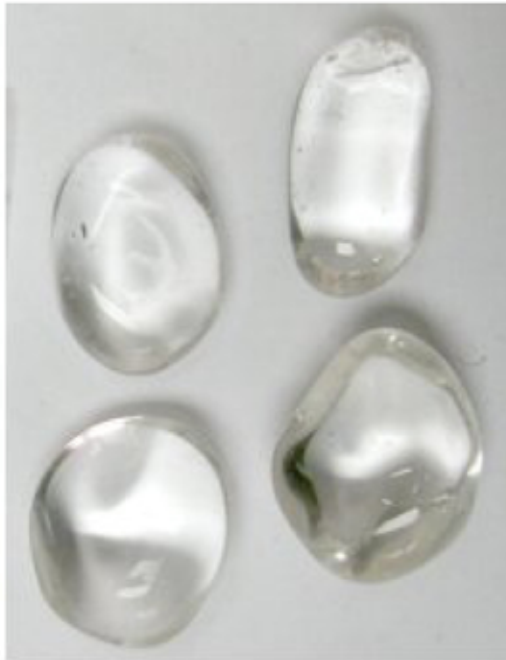
#### Sample Photo:

**R115 Quartz**
